RE: Reclamation District No. 341 (Sherman Island)
Project Funding Agreement SH-18-1.1-SP

Enclosed for you review and approval, is the revised Five-Year Plan submitted on the behalf of Reclamation District No. 341 (District). For your convenience, the comments in your letter dated February 23, 2021, are provided below in italics followed by the District's response:

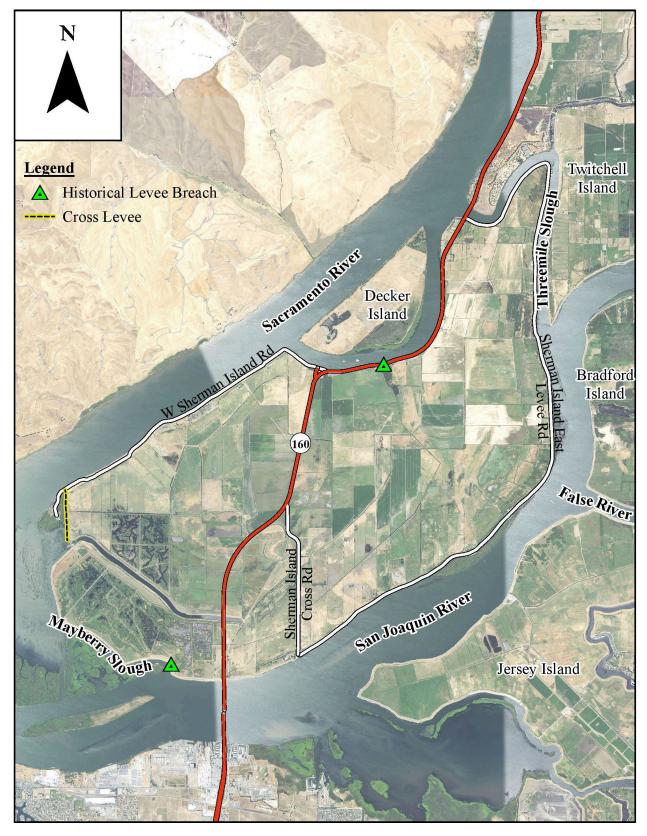
Figure 2. Location Map

Figure 2 (Location Map) has been revised to include the Cross Levee and sites of significant levee breaches.

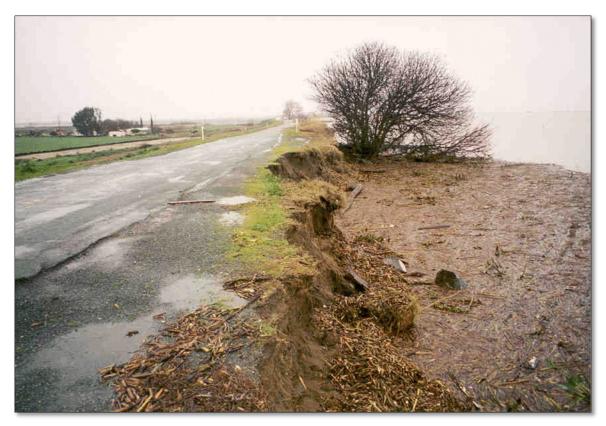
Figure 3. 1998 Erosion

Due to the large fetch on the San Joaquin River in the vicinity of Sherman Island, the San Joaquin River levee experienced severe wind wave erosion in the 1998 (Figure 3) and 2006 (Figure 4) flood events. The levee section has since been rehabilitated and armored with riprap slope protection on the waterside. Additionally, the levee section features a riprap splash cap on the waterside hinge for protection against wind wave runup.

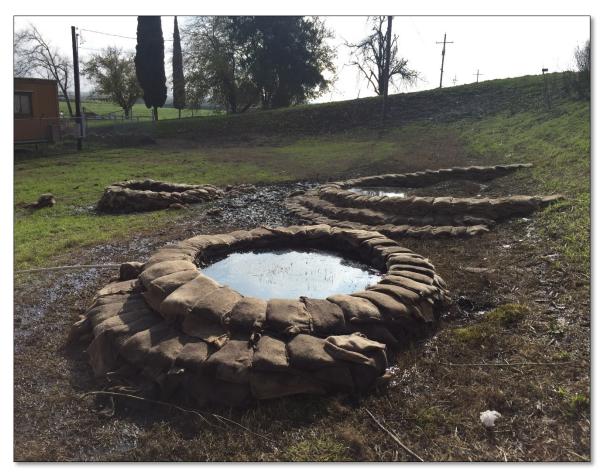
Figure 5. Boils at Sta. 960+00

On January 13, 2017, the District was contacted by the California Department of Transportation (Caltrans) regarding the sighting of boils on a portion of the levee system that supports Highway 160. The boils were located behind the District Office at approximate Sta. 960+00. The District contacted the County Office of Emergency Services and DWR State-Federal Flood Operations Center requesting assistance in containing the boils which were increasing in number and size. However, the District was unable to attain assistance from either. As a result, the District contacted the Rio Vista Fire Department, and with the assistance of the Fire Department, the District constructed sandbag rings around the boils (Figure 5).

On January 15, the District determined that with the high river stage and forecast for additional rain there was potential for levee failure and an emergency repair was required immediately. Emergency repairs began on January 16 and included the installation of filter fabric, ballast rock, soil cover and perforated pipe to capture and route seepage away from the levee slope and toe. Construction was completed on January 19.

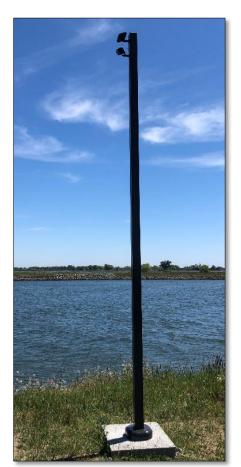
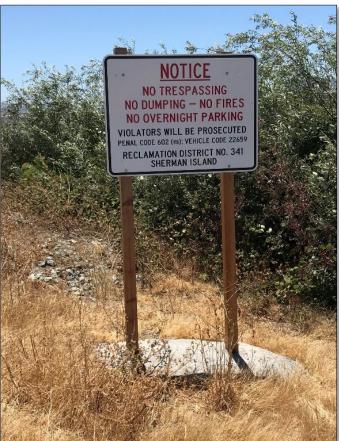
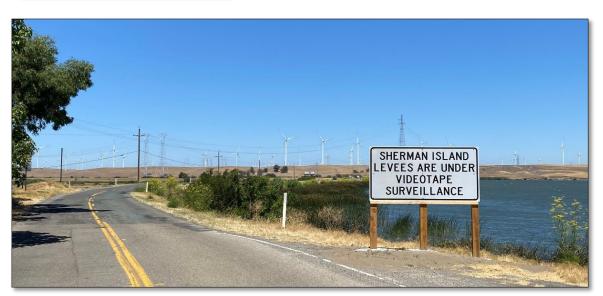
Figure 10. Security Camera and Signs

To combat these issues the District installed multiple Arlo GO 3G/4G LTE wireless security cameras to monitor entry points and District facilities. Additionally, the District installed 14 signs warning visitors of prohibited activities and 4 signs notifying the presence of the security cameras (Figure 10).

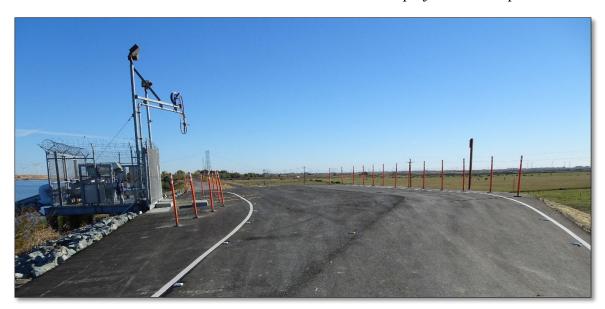
Figure 11. Manzo Ranch Fish Release Facility

DWR constructed a Fish Release Facility as a court ordered mitigation for water exports to Southern California. The Fish Release Facility project was implemented to comply with the National Marine and Fisheries Services' 2009 Biological Opinion on the Long-term Operations of the CVP, SWP, and CDFW's Longfin Smelt Incidental Take Permit for the SWP's Delta Facilities and Operations. Specific requirements are to reduce predation of salvaged fish at the fish release sites and increase salvaged fish survivals rates. The project consists of two separate fish release sites: Little Baja and Manzo Ranch (Figure 11). Also, as part of the project, the District rehabilitated the levee section from Sta. 700+00 – 740+00. The project was completed in 2018.

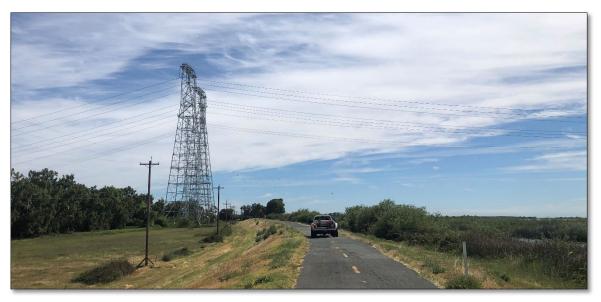
Figure 12. Transmission Lines at Sta. 300+00

Three major electric transmission lines (greater then 500kV) cross Sherman Island: the California Oregon Transmission Project, operated by the Western Area Power Administration, the Pacific Gas and Electric Company (PG&E) Table Mountain-Tesla line, and the PG&E Vaca-Dixon-Tesla line (Figure 12). These lines work mainly to interconnect California loads and generation with loads and generation in the Pacific Northwest. The three lines through the Delta are operated as a coordinated grouping, with maximum imports or exports limited to provide some joint redundancy to help ensure reliability. The DRMS report estimates that an outage of these transmission lines would cost the State approximately \$10.5 million per line per summer month (*Page 12-35*). Accounting for inflation, the cost would be approximately \$13 million per line per summer month.

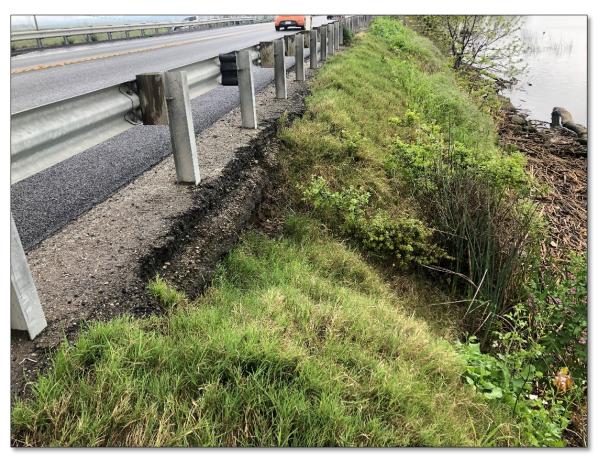
Figure 13. Highway 160 Erosion, Sta. 948+50

Under an emergency declaration, in July 2019 the District repaired the waterside levee slope from Sta. 945+50 – 951+00. Erosion in the levee section began to undermine the integrity of the Highway 160 shoulder leaving guardrail posts unsupported (Figure 13).

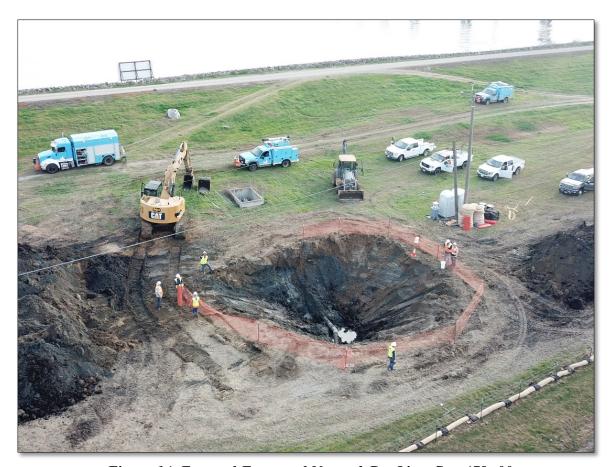
Figure 14. Exposed Fractured Natural Gas Line, Sta. 478+00

On February 26, 2020, a gas leak appeared near the levee toe at Sta. 478+00. Once the pipe was exposed it was discovered that the leak was a result of a vertical crack on the side of the pipeline adjacent to an elbow where the pipe changes direction (Figure 14). It was also discovered that the gas line was resting on another pipe located directly beneath; the other pipe was an abandoned drip line that used to remove condensation from the gas line to prevent corrosion. PG&E theorized that settlement had caused the two pipes to come together over time and the force between the two caused the crack in the pipeline.

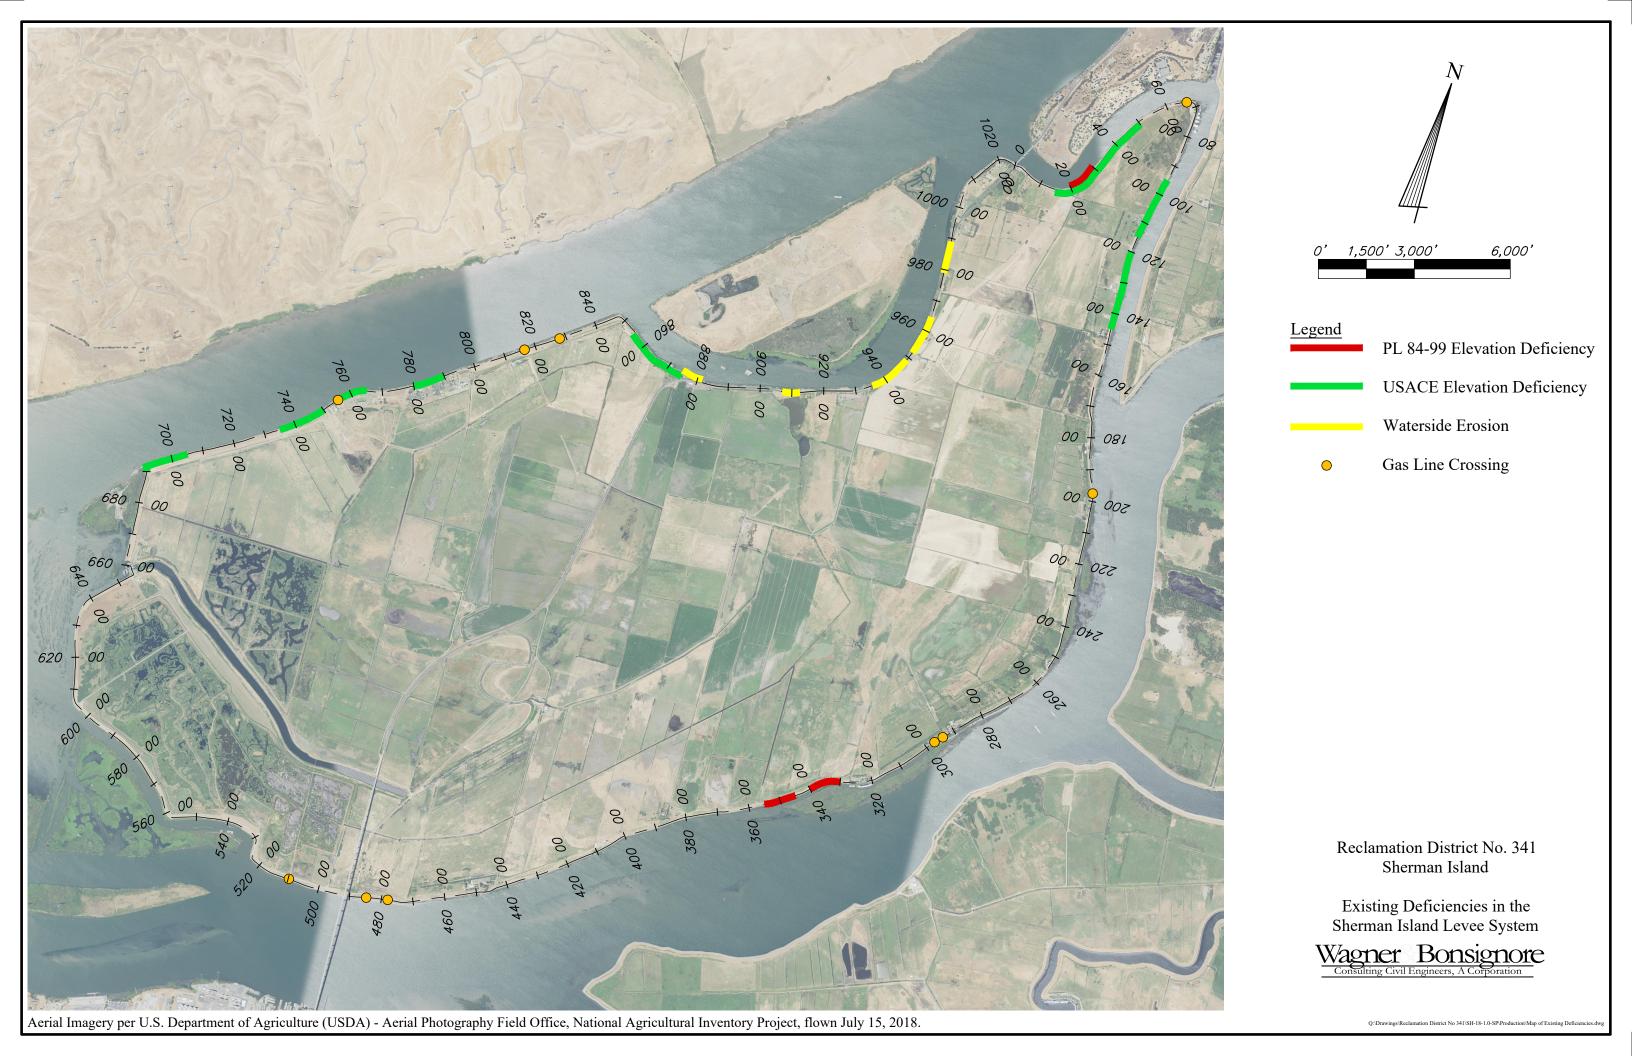
EXHIBIT 5. MAP OF LEVEE SYSTEM DEFICIENCIES

The Sherman Island levee system contains elevation deficiencies relative to the PL 84-99 and USACE Standards, waterside erosion that could compromise Highway 160, and natural gas line crossings that could pose a threat if they were to fail. A map of Sherman Island levee system deficiencies is included as Exhibit 5. A levee centerline profile, which includes PL 84-99 and USACE design elevations, is included as Exhibit 6.
